Report on the investigation of  
the entrapment of an engine room fitter  
in a watertight door  
on board the ro-ro passenger ship

***Eurovoyager***

approaching Ramsgate, UK

**Report 17/2009**  
**July 2009**

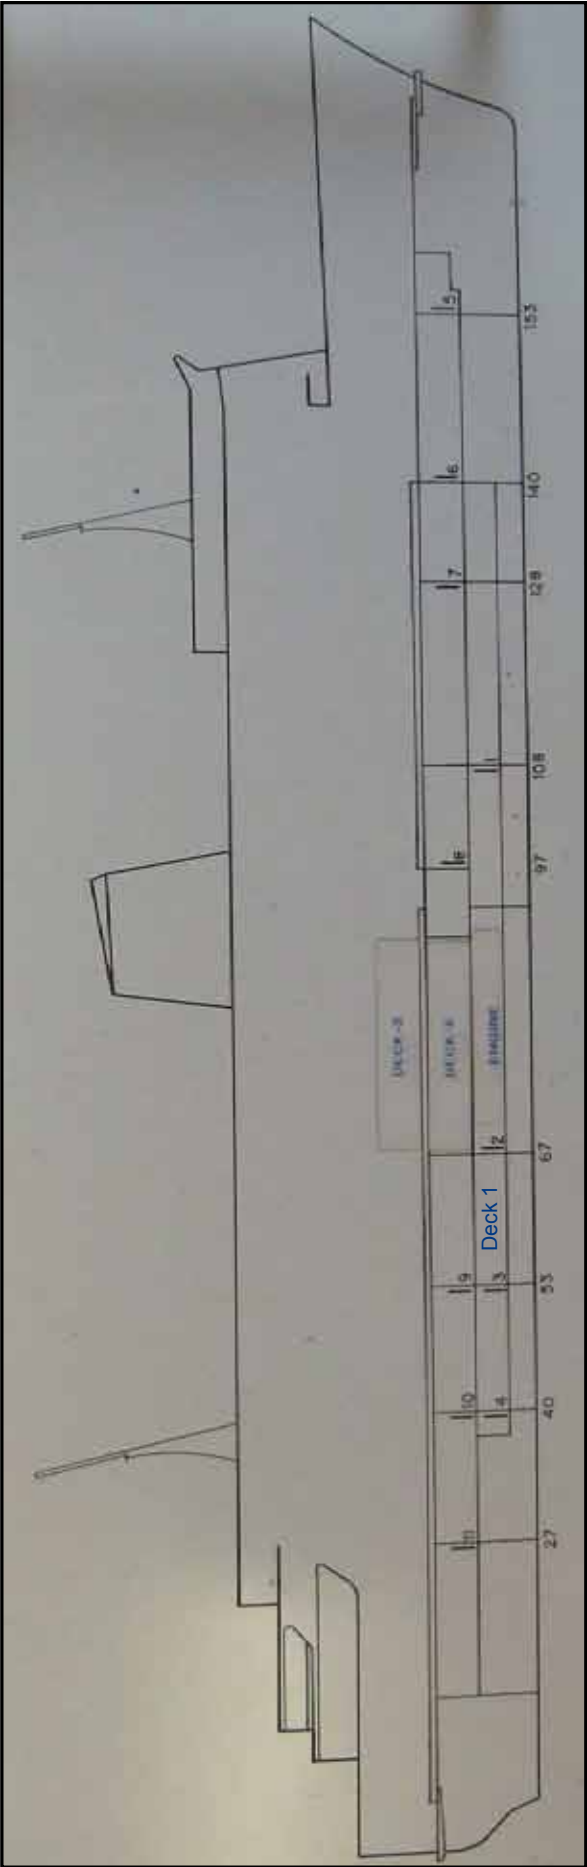
Figure 4

There were 11 watertight doors, excluding the bow and stern doors and 4 weathertight deck barriers. Four of these doors were located in the machinery space (Deck 1), and the remaining 7 on Deck 2 (**Figure 4**). All of the doors were made of solid steel and were identical in construction except for two in the accommodation, which were narrower. WTD1 measured 1800mm x 750mm (**Figure 5**).

Diagram showing the location of the watertight doors
